ACCIDENT INVESTIGATION REPORT
(UNDERGROUND COAL MINE)
NON-FATAL COAL OUTBURST ACCIDENT
NO. 37 MINE (I.D. NO. 15-04670)
ARCH OF KENTUCKY, INCORPORATED
CUMBERLAND, HARLAN COUNTY, KENTUCKY

REPORT OF INVESTIGATION (UNDERGROUND COAL MINE)

NON-FATAL COAL OUTBURST ACCIDENT NO. 37 MINE (I.D. NO. 15-04670) ARCH OF KENTUCKY, INCORPORATED

MAY 8, 1989

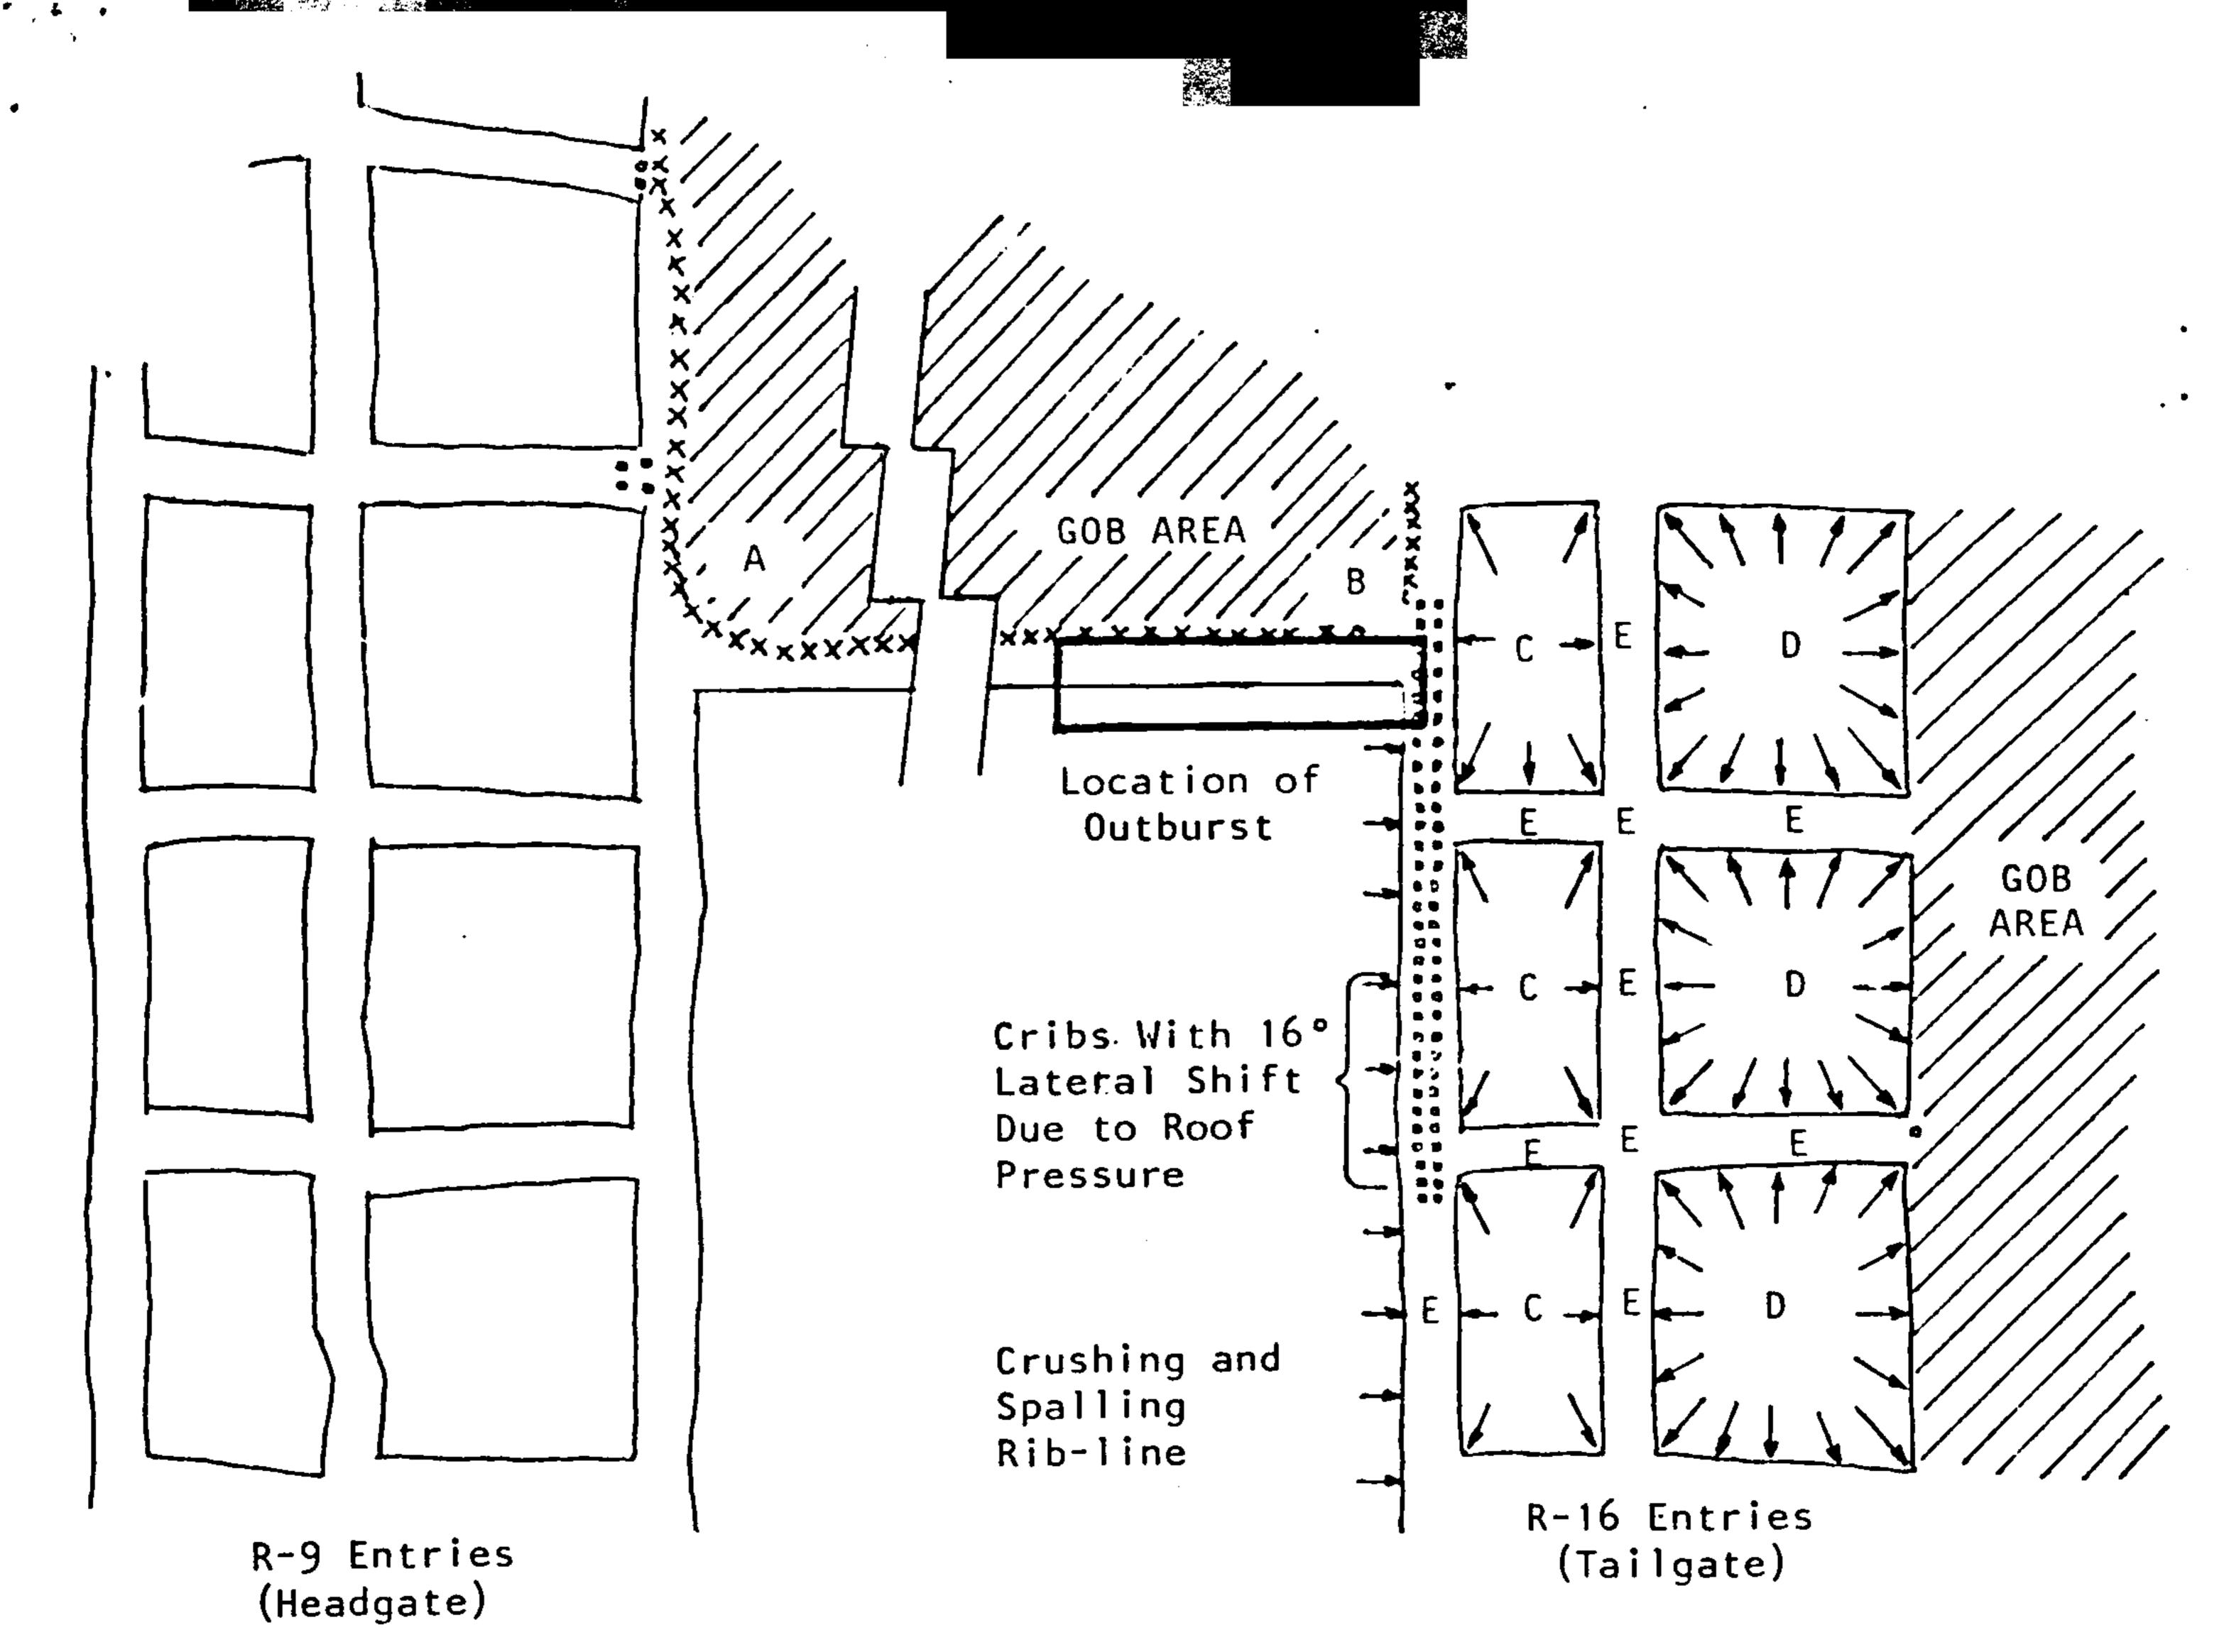
Sketch Number 5

- 8. An area of soft, broken floor was observed from the No. 73 shield to the No. 79 shield, a distance of twenty-five feet.
- 9. Evidence of excessive loading was observed in the No. 2 entry of the R-16 (tailgate) entries, approximately one-hundred-seventy feet outby the longwall face. The coal pillars were crushed out and the mine floor had heaved.

- 11. The immediate roof, laminated shale and sandstone, had caved to a height of approximately fourteen feet on the headgate end of the longwall gob area and approximately twelve feet on the tailgate end. The main (sandstone) roof, was observed above the fallen material at both locations.

A - Caved to approximately 14'

B - Caved to approximately 12'

C - Partially crushed pillars

D - Completely crushed pillars

E - Floor broken and heaved

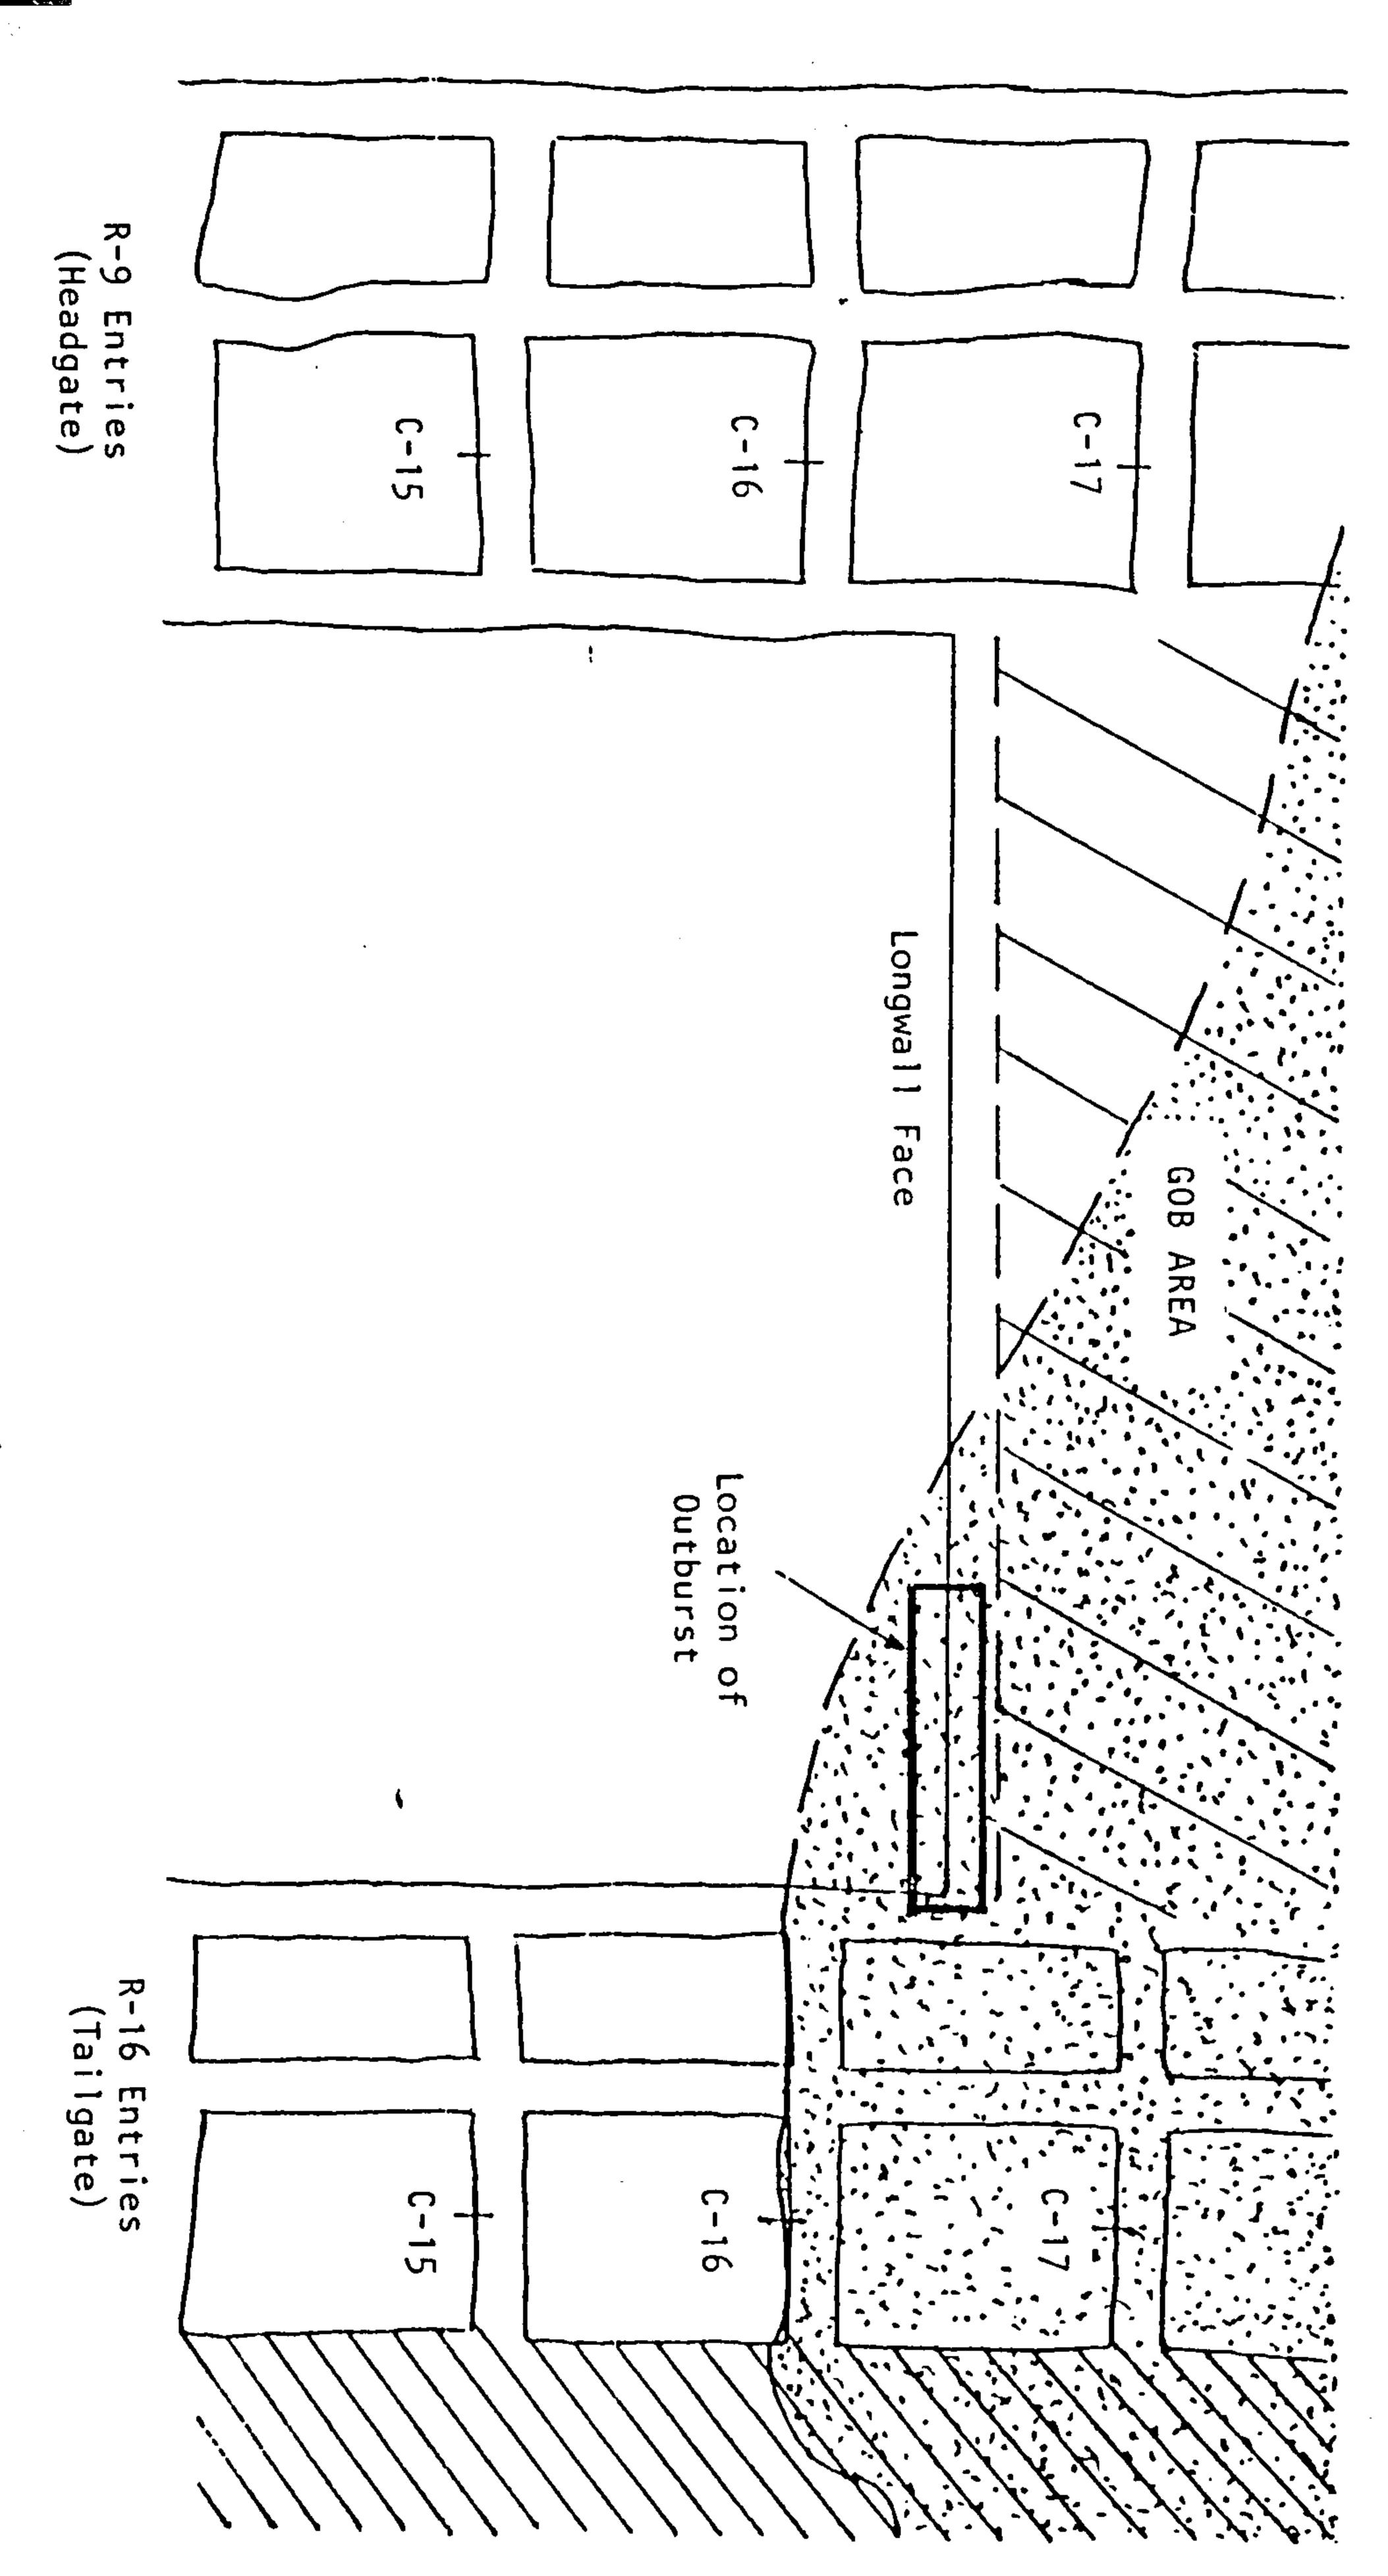
Sketch Number 6

- The longwall panel (total length approximately seventhousand-five-hundred feet) had been mined approximately one-thousand-five-hundred feet to where mining ceased due to a sandstone roll at the No. 49 crosscut. The unit was moved to the No. 42 crosscut, a distance of approximately eight-hundred-forty feet.

- 7. Mining was completed in November, 1988, in the adjacent area (tailgate side) between the Nos. R-16 and R-22 entries.

- Projected Roll

Mined Out Area (R-16 to R-22)
